Subject: Weekly Monitoring Report for Week Ending 08/24/2019

Florence Copper, Production Test Facility

Aquifer Protection Permit No. 106360, LTF 61845

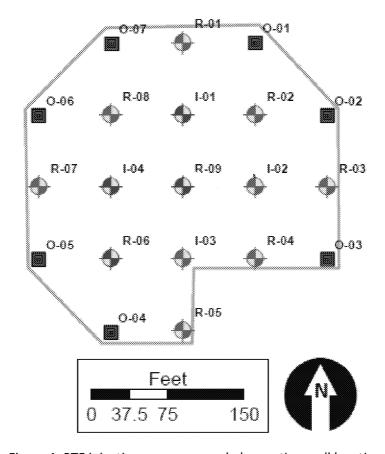
A map showing the location of the PTF injection, recovery, and observation wells is included as Figure 1.

Figure 1. PTF injection, recovery, and observation well locations

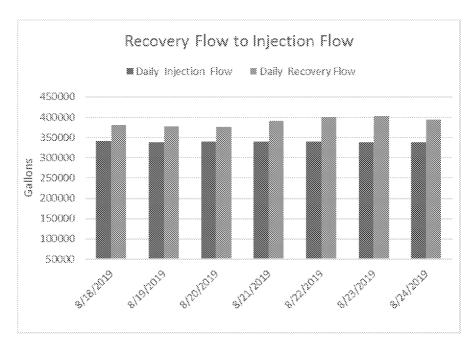
A summary of the injected and recovered volumes for the week of 08/18/2019 to 08/24/2019 is included in Table 1. The total injected and recovered volumes for the PTF as a daily total are also presented on Figure 2.

During the reporting period no exceedance of the alert level was measured for recovered volume to injected volume. The alert level is the recovered volume shall exceed the injected volume.

Figure 2. Recovered volume to injected volume

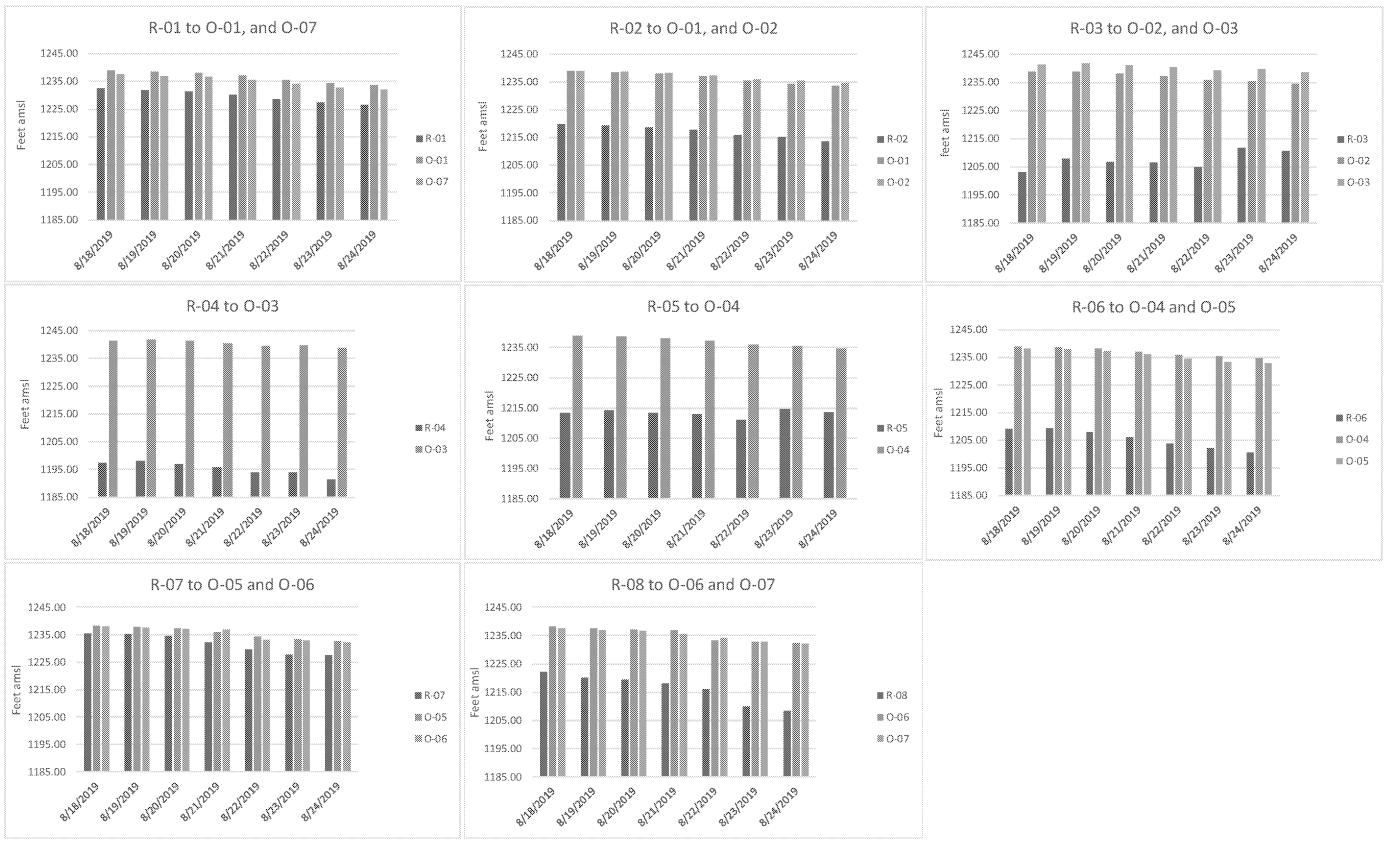
Figure 3

Table 2 includes a summary of water levels in the recovery and observation well pairs. Hydrographs showing the water level elevation for each recovery well and observation well pair are included in Figure 3.

During the reporting period, there was no exceedance of the alert level for the inward hydraulic gradient. The alert level for the inward hydraulic gradient is that the water level elevation in the paired observation well must be a minimum of 1 foot higher than the paired recovery well.

Figure 3. Recovery and observation well pairs
